**UNITED STATES AIR FORCE
ELMENDORF AIR FORCE BASE, ALASKA**

**OPERABLE UNIT 5
REMEDIAL INVESTIGATION/FEASIBILITY STUDY**

VOLUME 1 - TEXT

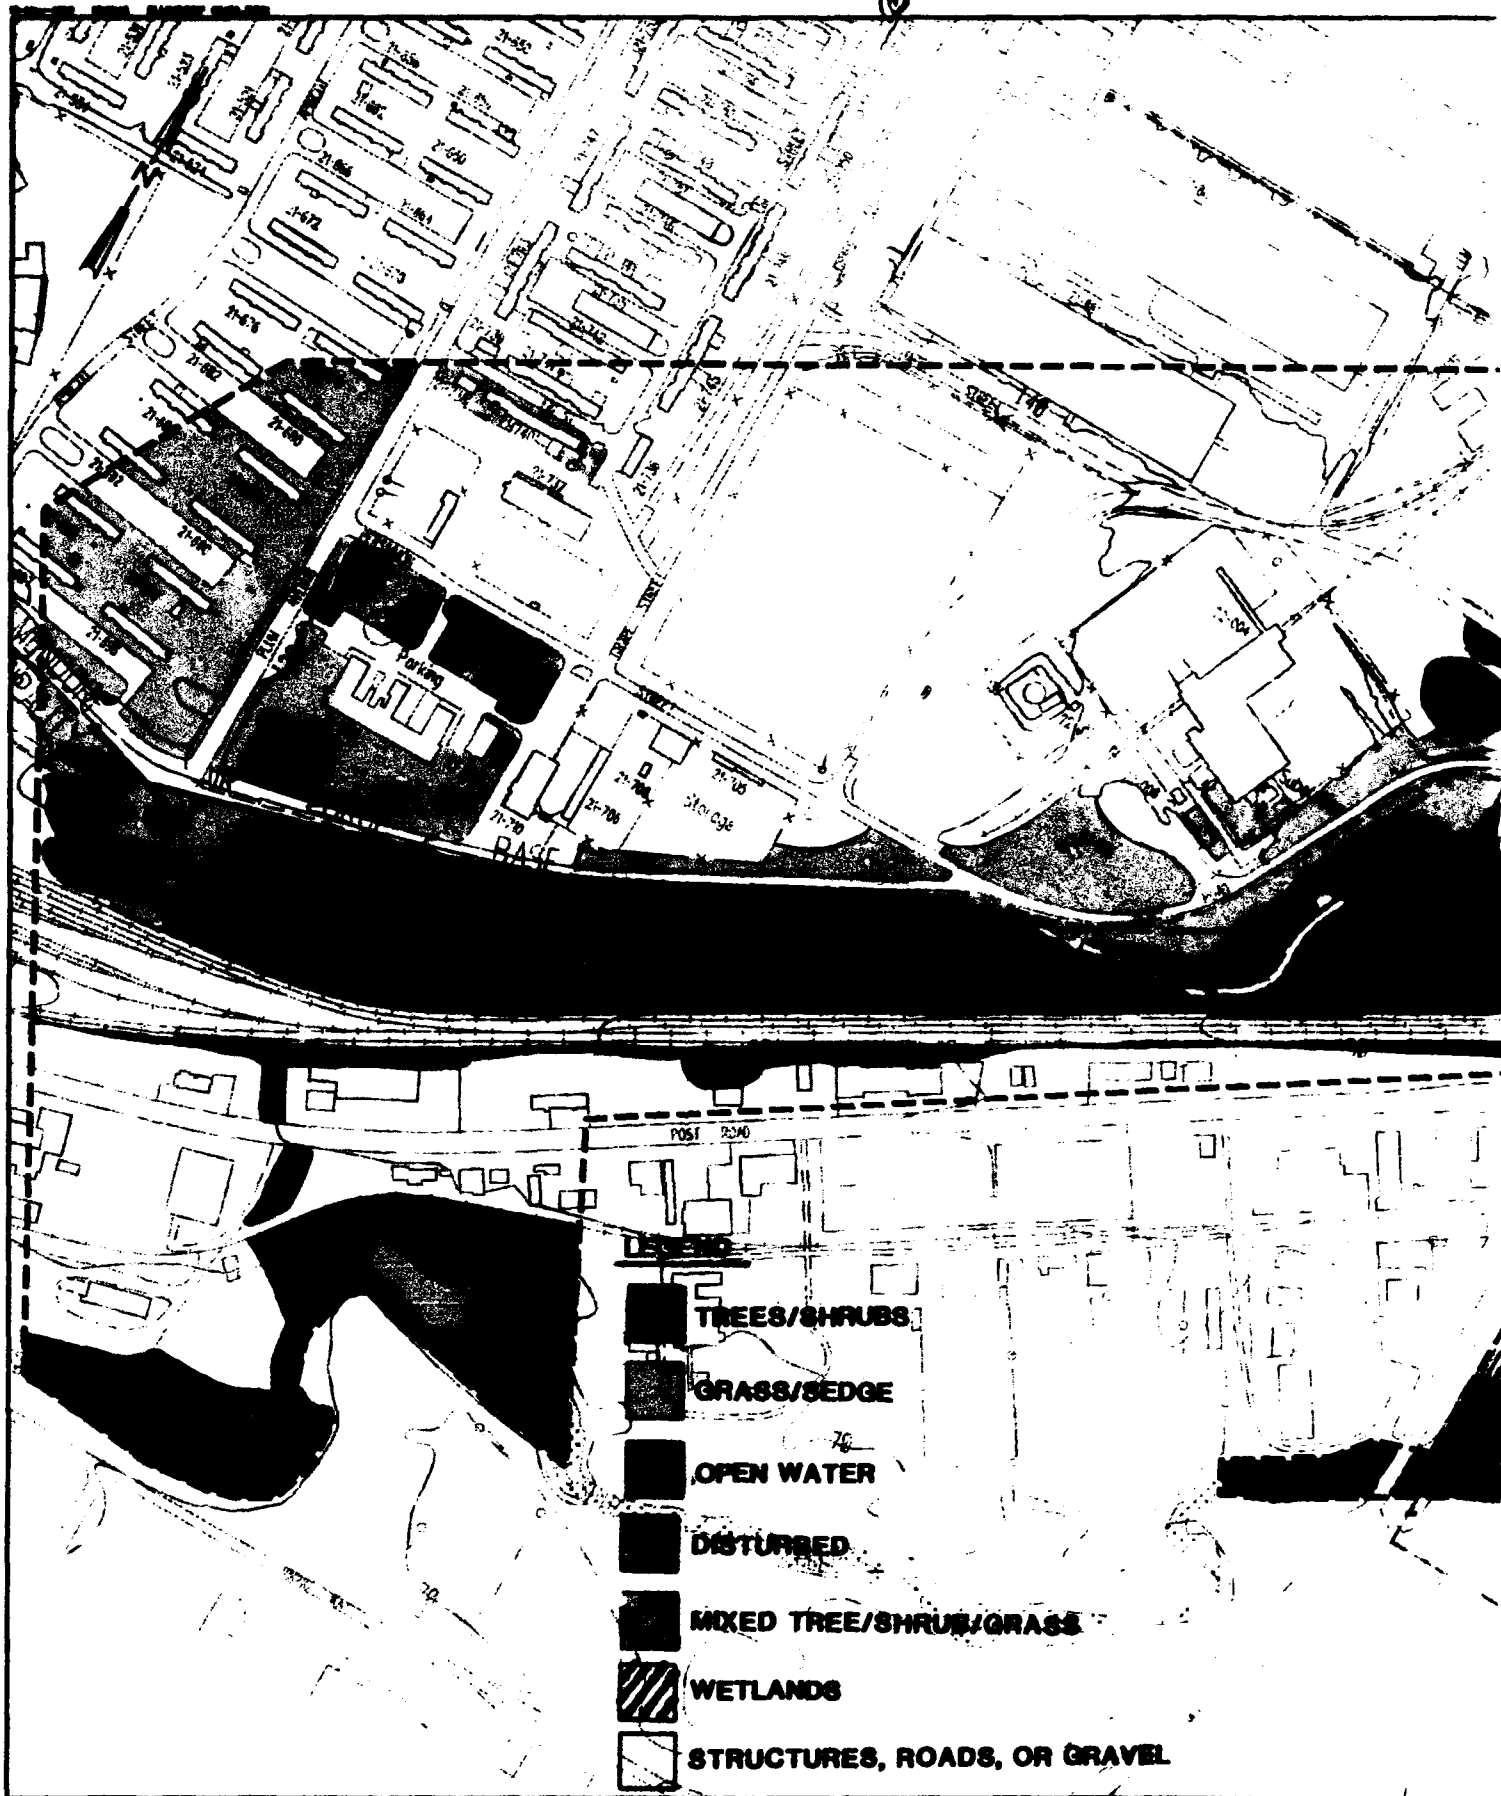
FIGURE 3.14a
GENERAL HABITAT FEATURES

The distribution and composition of habitat types within OU 5 are generally similar to their occurrence in 1982 (Rothe et al, 1983, CH2M HILL, 1992c) to the extent that they were described. Within OU 5, the habitat mapping by Rothe et al (1983) did not include the areas between the bluff and railroad tracks west of the junction of Reeve Boulevard and Post Road; these areas are outside Elmendorf AFB. However, from the aerial photographs taken in 1982, most of that area (including all of Source ST37) appeared to have been a balsam poplar (*Populus balsamifera*) forest, as it was during the 1992 surveys.

From the snow disposal area (near SL28) eastward to Post Road, most areas between the bluff and the railroad tracks were occupied by a mixture of woody species. The area included trees, shrubs and understory species typical of the closed balsam poplar forest and closed alder (*Alnus* sp.) tall scrub-shrub that were mapped in this area (Rothe et al, 1983). One notable exception was the apparent absence of devil's club (*Echinopanax horridum*) and lower abundance of highbush cranberry (*Viburnum edulae*) and American red currant (*Ribes triste*) than that of cow parsnip (*Heracleum lantanum*) in the understory. Between the railroad tracks and Post Road, the habitat was largely open with species characteristic of the bluejoint grass mesic graminoid herbaceous type. In addition to grasses and sedges, there were various herbaceous plants such as fireweed, cow parsnip, yarrow (*Achillea borealis*), and horsetail in this area. Trees and shrubs were limited to a few small stands.
